APPENDIX V – CONTAMINATED LAND TECHNICAL NOTE

Range Environmental Consultants

Our Reference: J000926 Date: 21/06/2022

TOOWOOMBA CLAY TARGET CLUB CONTAMINATED LAND ADVICE - PROPOSED CHARLTON SPORTS PRECINCT

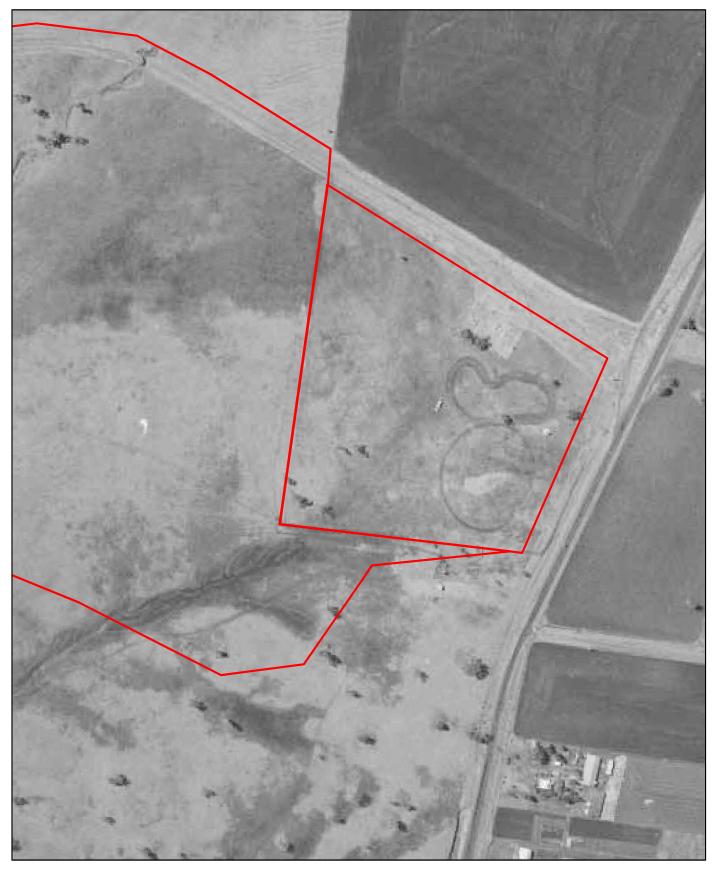
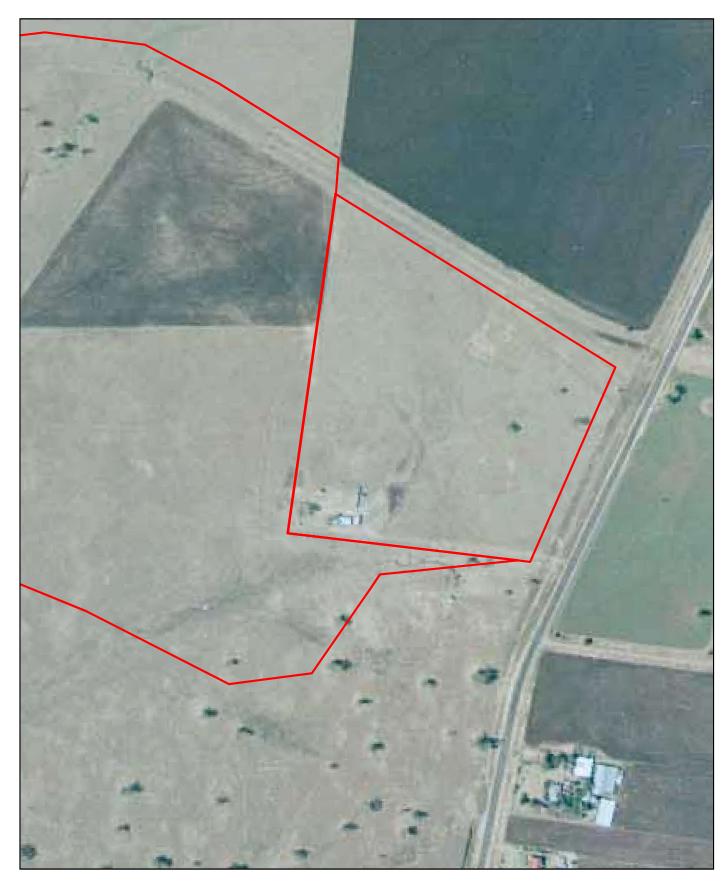
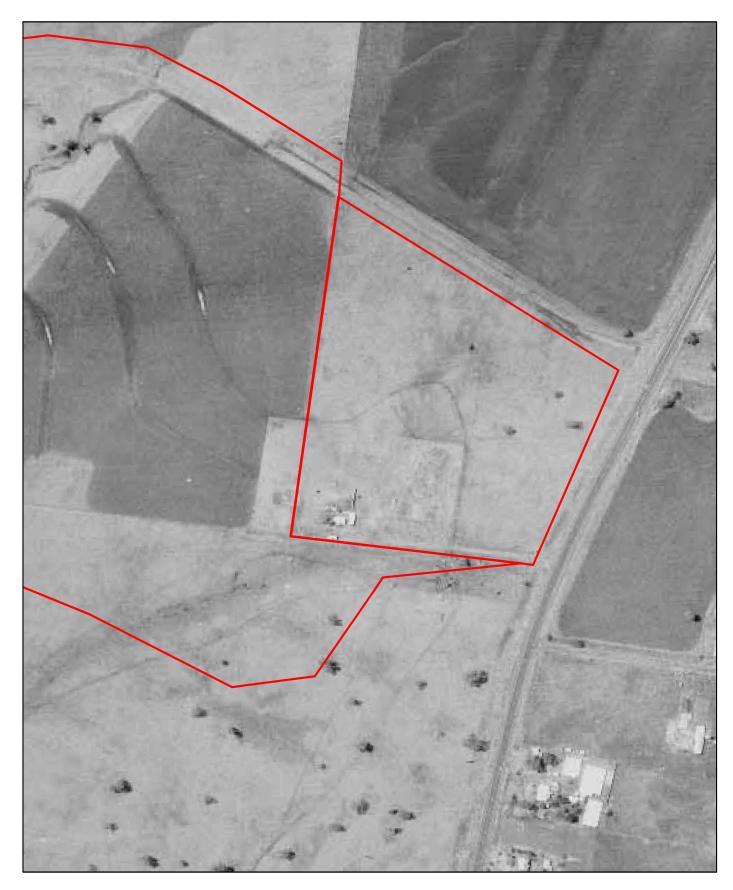
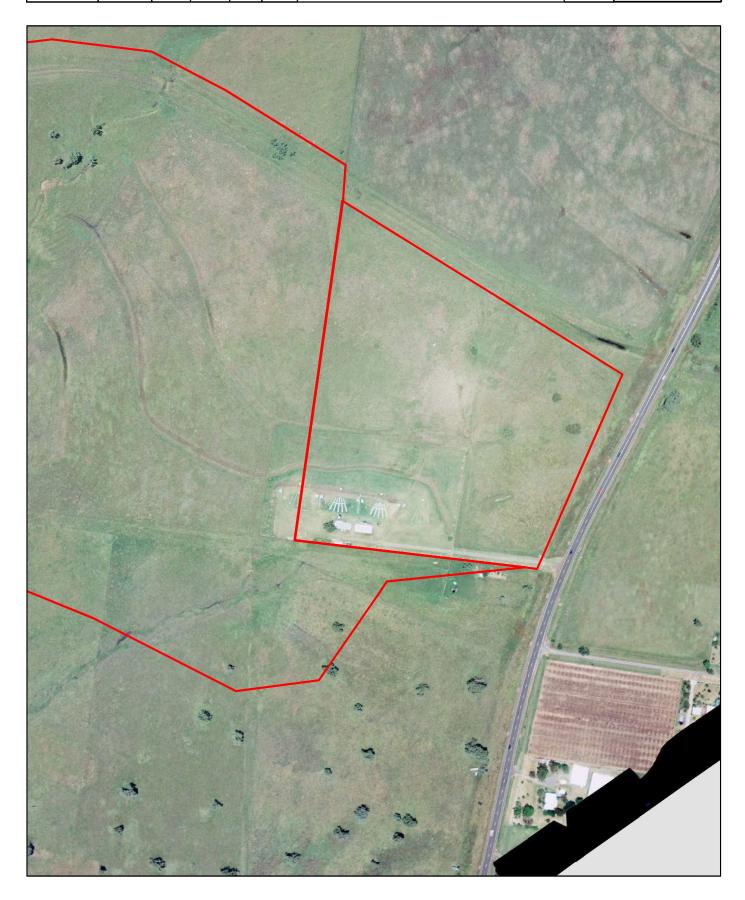
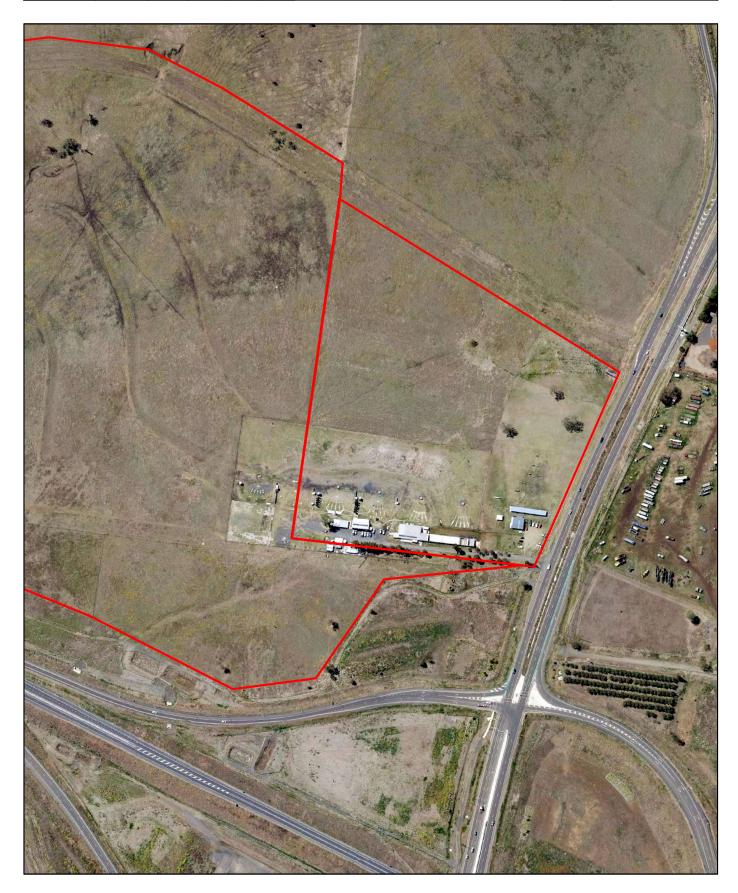
Appendix B: Historical Aerial Imagery

Period	Land use activities & development
Pre-1965	 Undeveloped - rural The site was undeveloped with some sporadic overstorey vegetation. An unsealed track occurred within the southern extent of Lot 276 on SP268921.
1965-1975	 The TCTC moved to its current location in 1966.¹ A small structure occurred in the north-western corner of Lot 276 on SP268921. This was considered likely to be associated with the TCTC.
1975-1984	 A large rectangular area (considered likely to be the footprint of the TCTC) extended north into Lot 24 on SP214746 (circled in blue).
1984-1999	 Shooting activities were considered likely to occur on both Lot 276 on SP2686921 and Lot 24 on SP214746. Shooting stations and a clay target trap occurred in the northern extent of the TCTC footprint within Lot 24 on SP214746 (circled in blue).

Period	Land use activities & development
1999-2021	 Toowoomba Clay Target Club The TCTC footprint extended further north, with an additional shooting station occurring on Lot 24 on SP214746 (circled in blue).
	Toowoomba Company of Archers
	• The archery club began operations from the southern extent of Lot 276 on
	SP268921 between 1999 and 2022 (circled in green).
	 A review of historic aerial imagery determined it was unlikely that shooting
	activities occurred across the southern extent of Lot 276 on SP268921. This
	portion of the site remained undeveloped until the archery club began
	operations between 1999 and 2021.

The chronology of the TCTC development is briefly described in Table 1. Historical aerial imagery for the TCTC development is located at Appendix B:.
